**SUMMARY REPORT FOR THE
TORCH LAKE AREA ASSESSMENT
TORCH LAKE NPL SITE
AND SURROUNDING AREAS
KEWEENAW PENINSULA, MICHIGAN**

Date Prepared	December 13, 2007
TDD Number	S05-0002-0708-020
Contract Number	EP-S5-06-04
Document Control Number	274-2A-ABDT
START Project Manager	Daniel M. Capone
Telephone No.	(906) 482-3085
U.S. EPA On-Scene Coordinator	Brian Kelly

EXECUTIVE SUMMARY

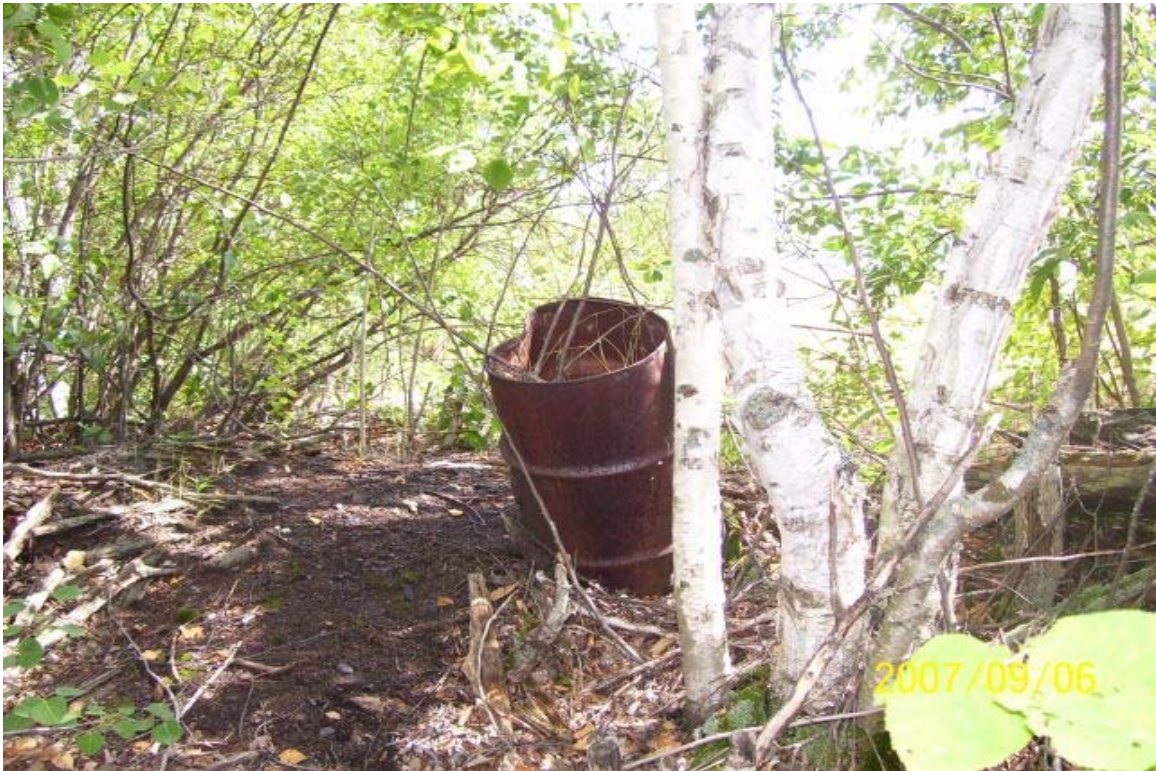
Site: Torch Lake Area Assessment
Photo Number: 3
Direction: North
Subject: Drum at Building in Mason (AOI 18)

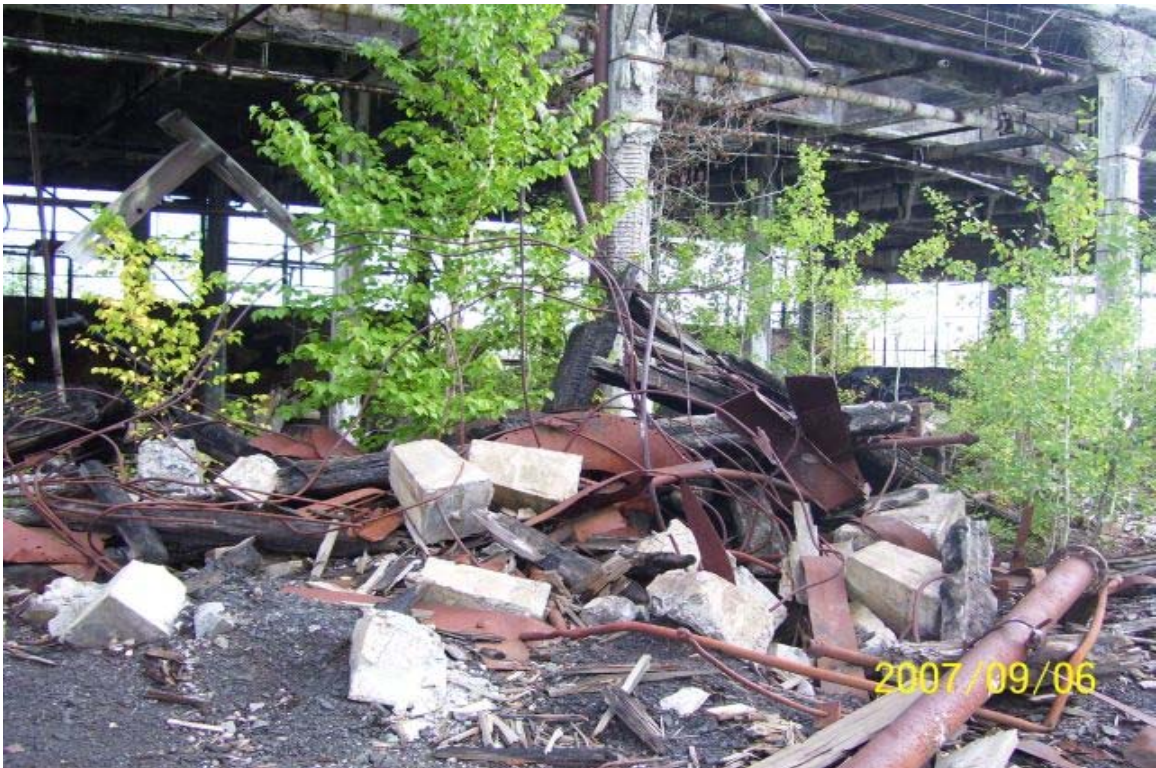
Site: Torch Lake Area Assessment
Photo Number: 4
Direction: East
Subject: Building 2 at Building in Mason (AOI 18)

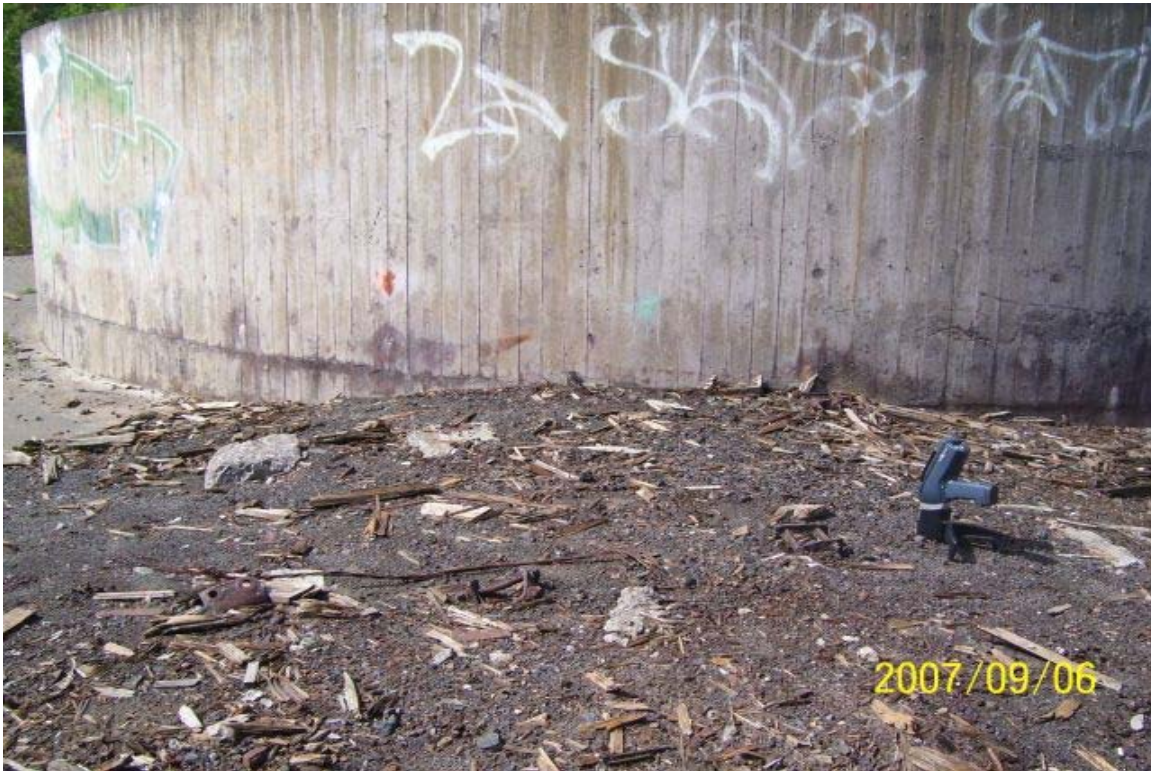
Photo Number: 7

Subject: Stained stamp sand and slag at Quincy Leach Plant (AOI 10)

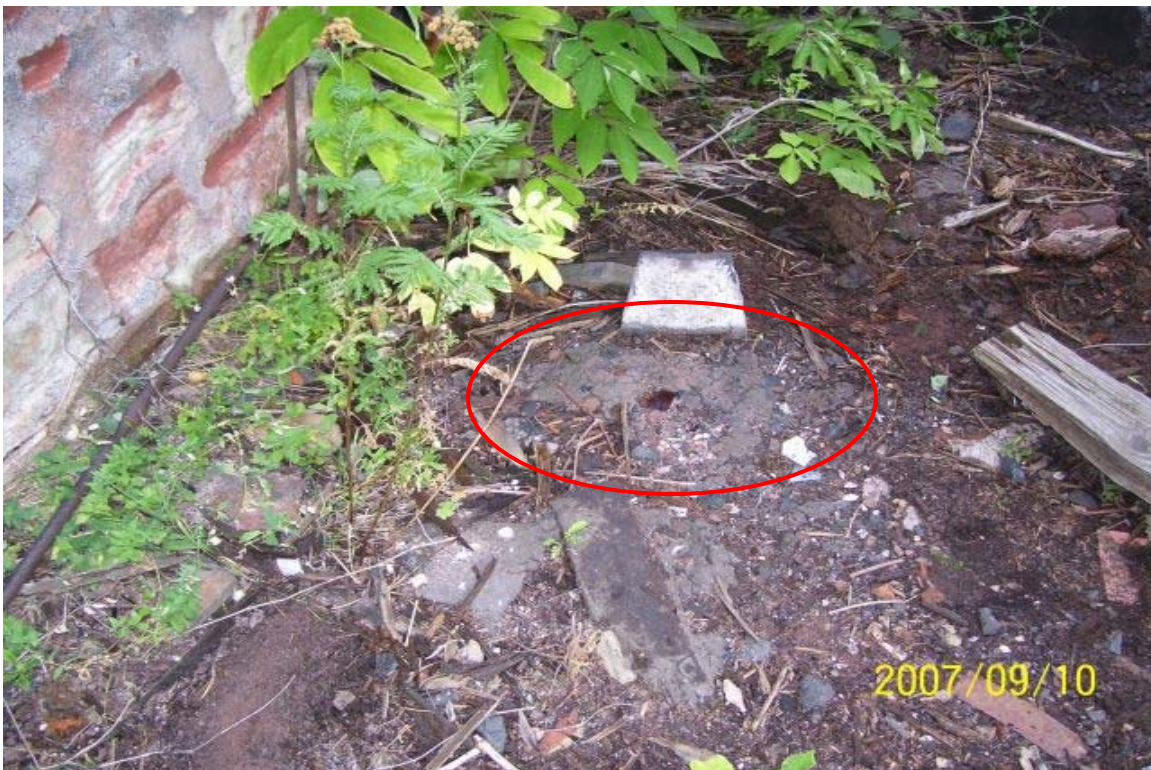
Photo Number: 20

Subject: Brown tar-like material at Former Houghton County Gas & Coke (AOI 15)

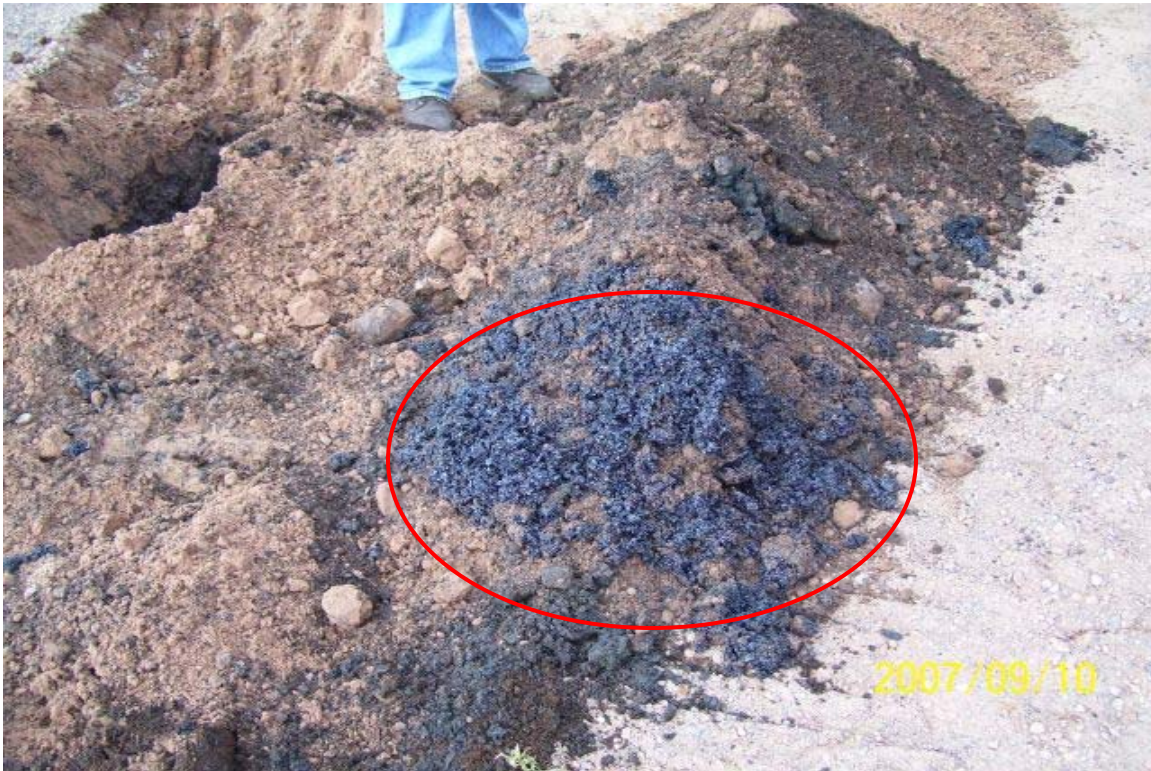
Photo Number: 21

Subject: Black, stained soils at Gay Stamp Sands (AOI 14)

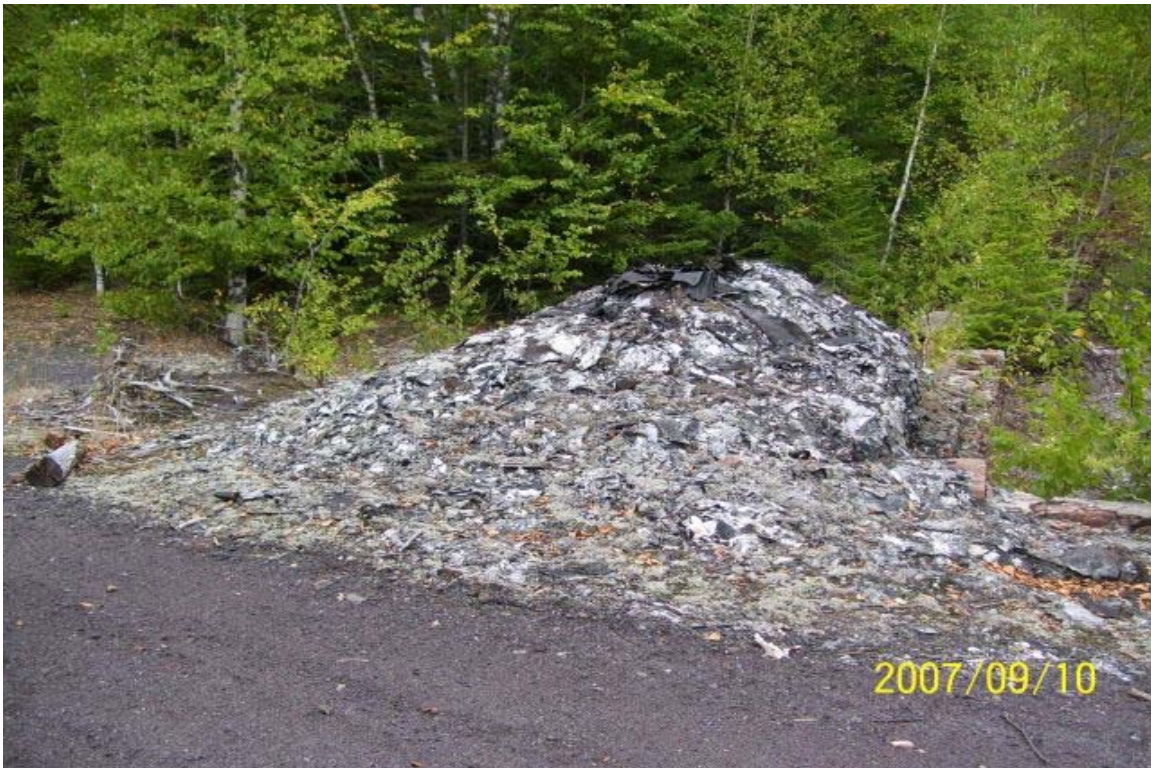
Site: Torch Lake Area Assessment
Photo Number: 28
Direction: West
Subject: Pile of asbestos-containing roofing material at Gay Stamp Sands (AOI 14)

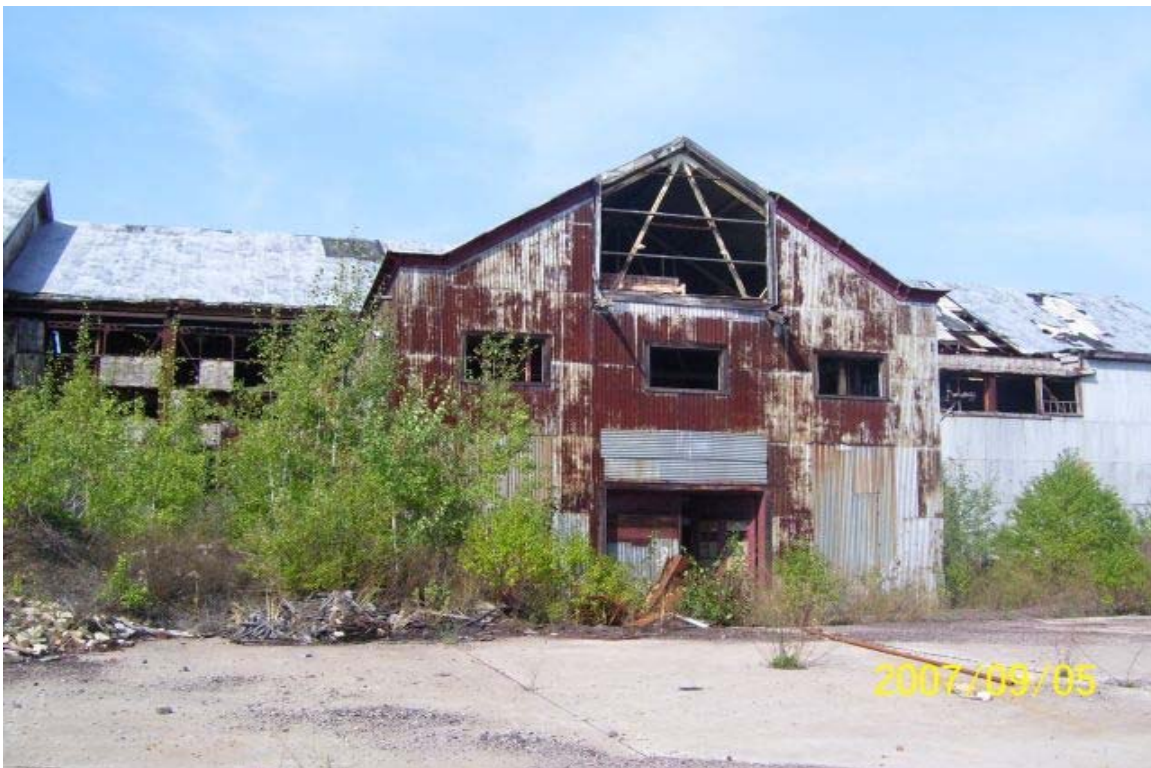
Site: Torch Lake Area Assessment
Photo Number: 30
Direction: West
Subject: Power plant building at C&H Power Plant Site (AOI 23)

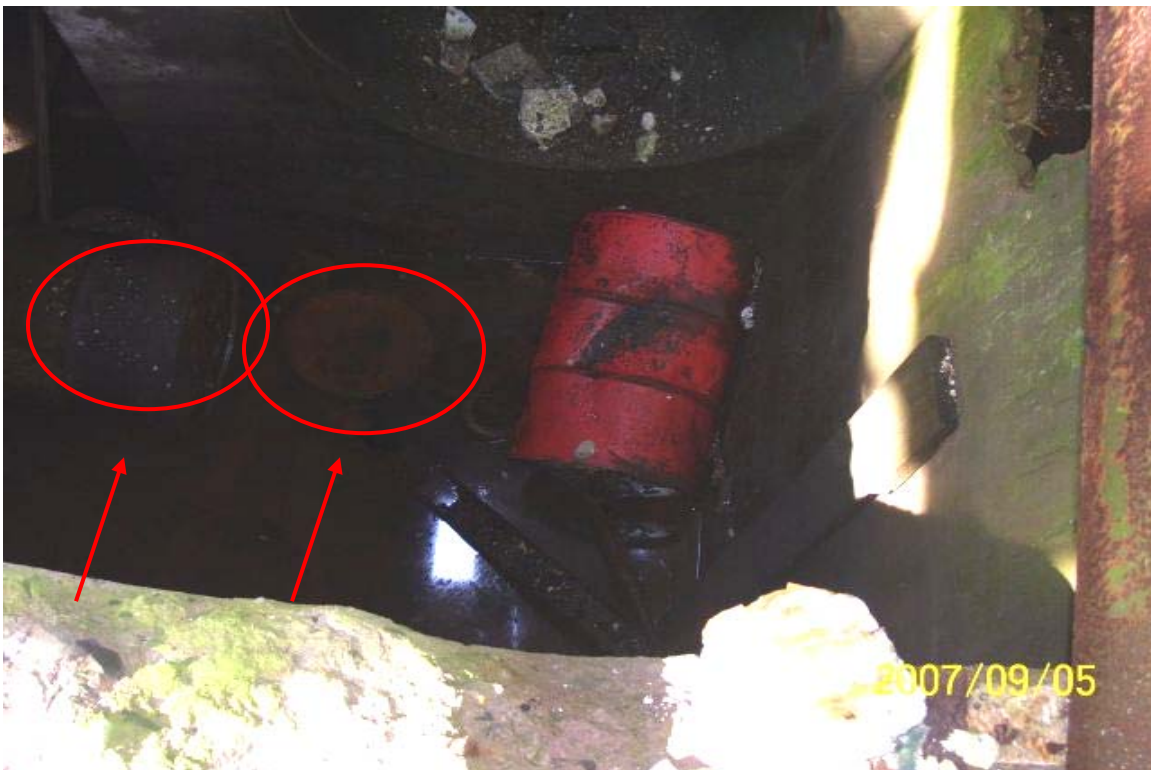
Site: Torch Lake Area Assessment
Photo Number: 32
Direction: West and down (basement level)
Subject: Partially submerged and leaking drums at C&H Power Plant (AOI 23)

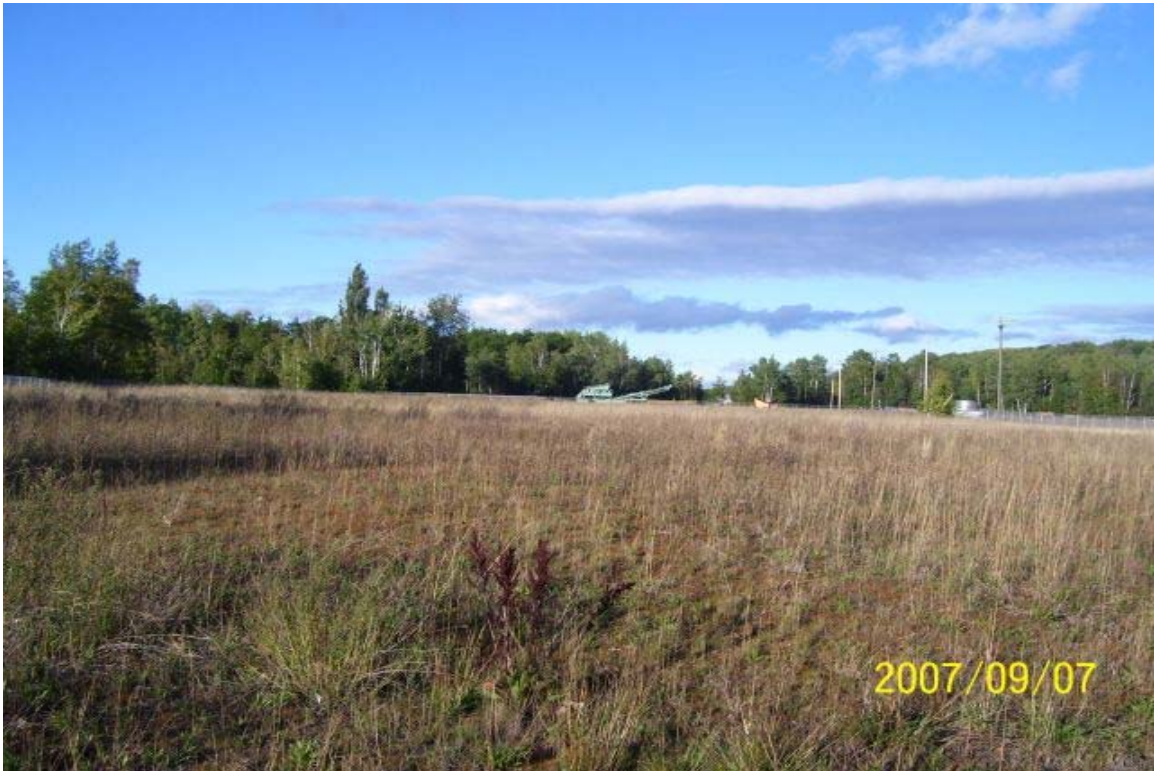
Site: Torch Lake Area Assessment
Photo Number: 35
Direction: North
Subject: Capped area at Dollar Bay (AOI 17)

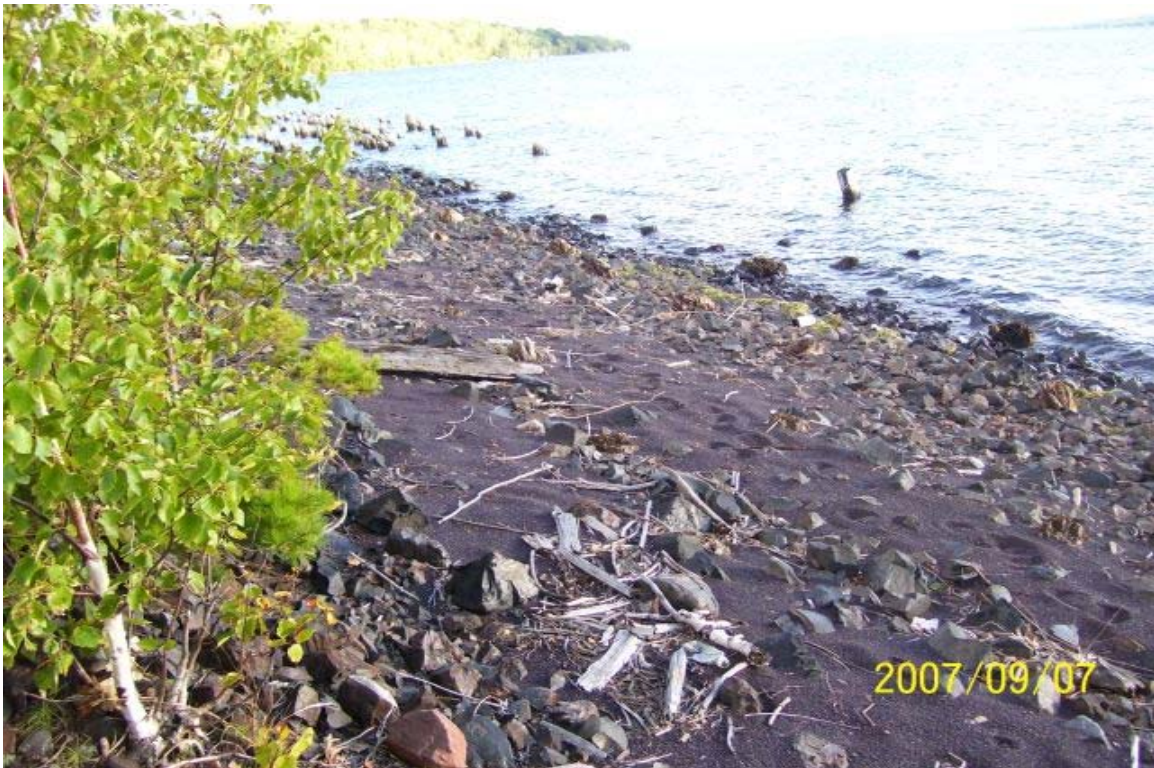
Site: Torch Lake Area Assessment
Photo Number: 36
Direction: East
Subject: Shoreline at Dollar Bay, uncapped area (AOI 17)

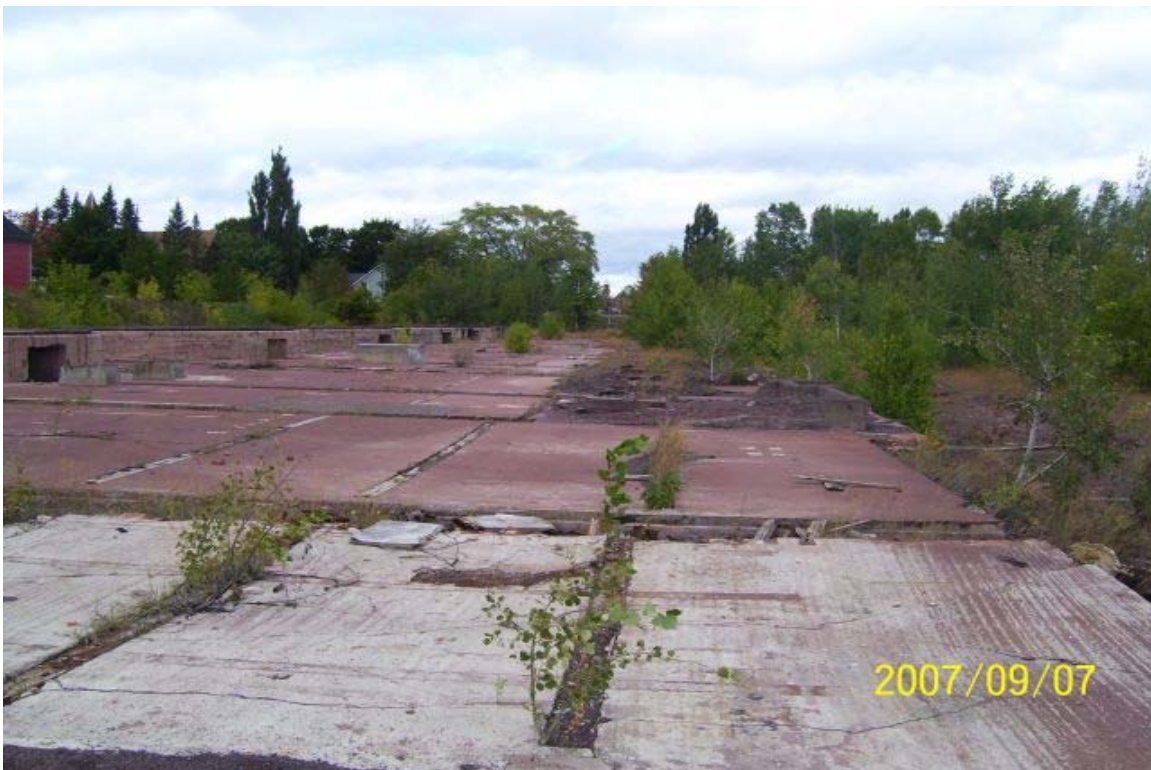
Site: Torch Lake Area Assessment
Photo Number: 37
Direction: East
Subject: Dollar Bay Well Field (AOI 17)

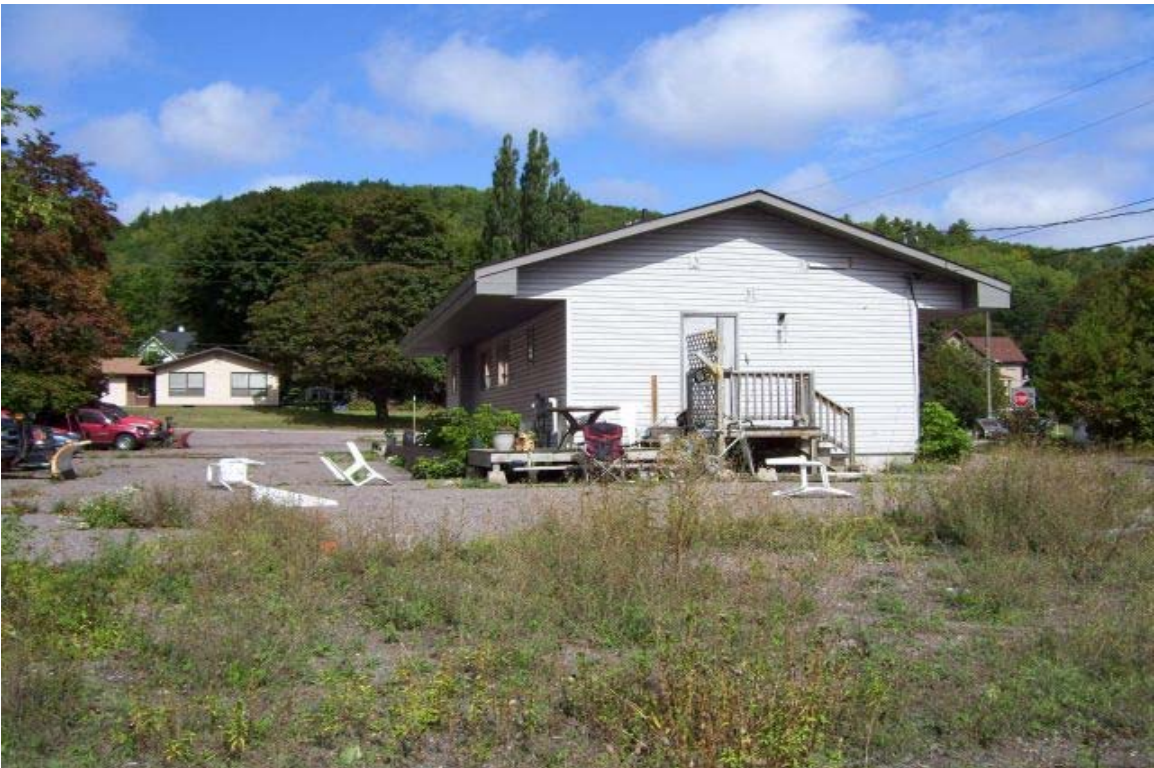
Site: Torch Lake Area Assessment
Photo Number: 41
Direction: Southwest
Subject: H&Y Marina (AOI 15)

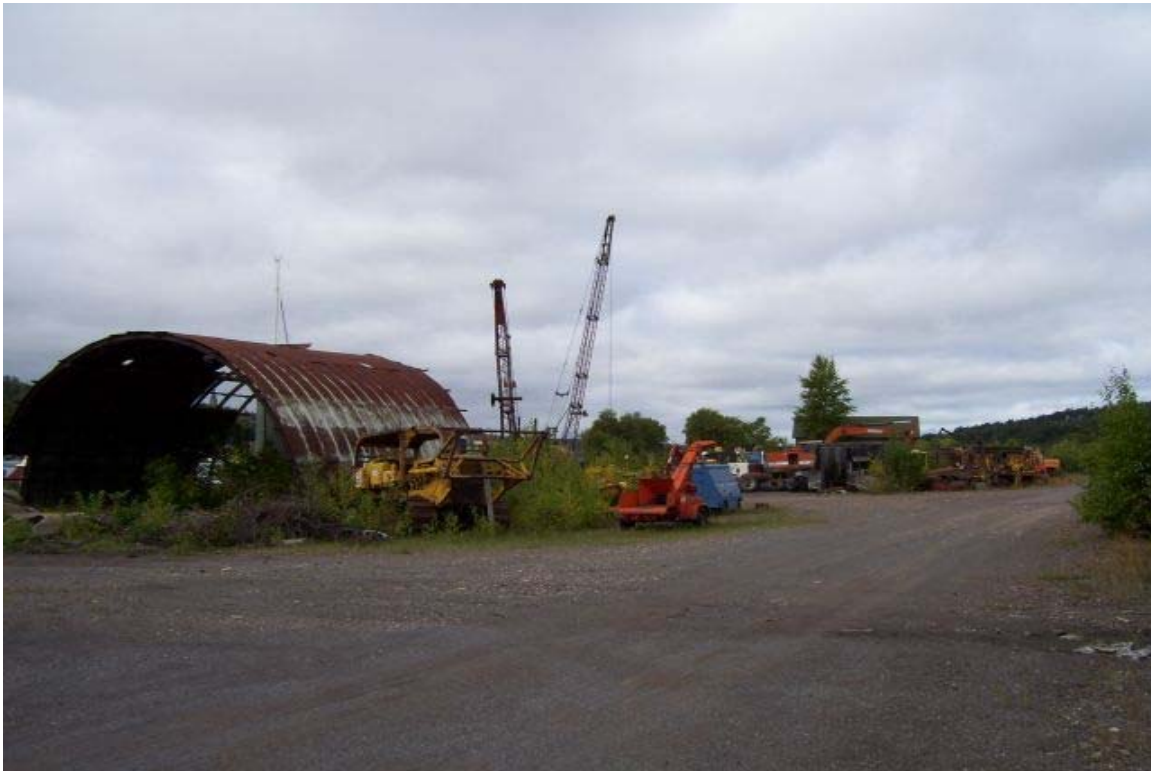
Site: Torch Lake Area Assessment
Photo Number: 42
Direction: North
Subject: Hanke property (AOI 15)

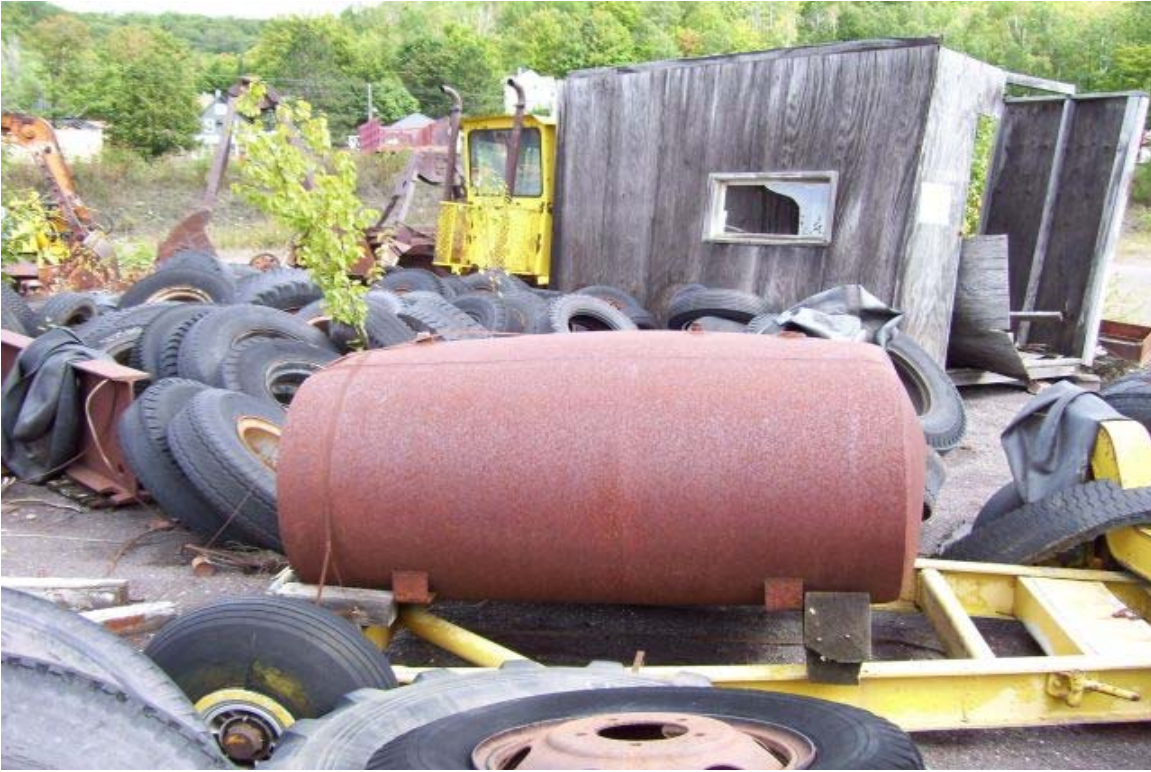
Photo Number: 44

Subject: Bulging and leaking drums at Julio Contracting (AOI 15)

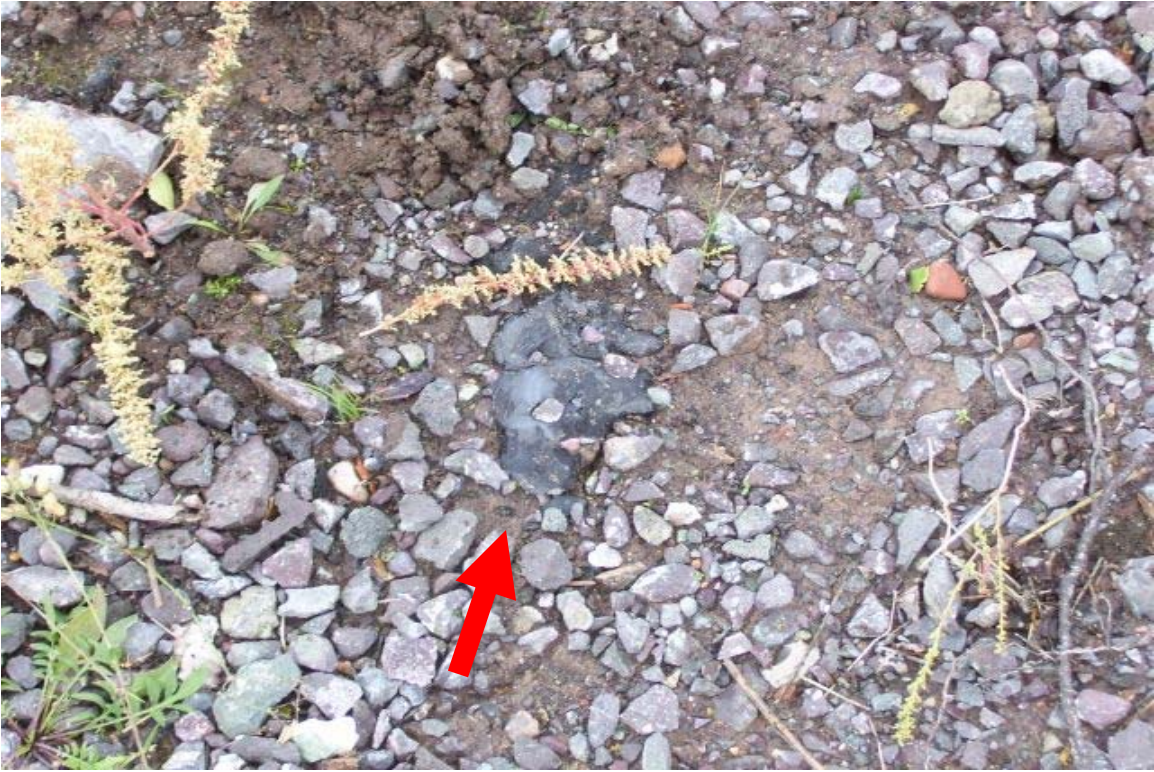
Tar was also observed at the property shoreline. It appears as though the tar seeps to the ground surface during warmer weather.

Subject: Tar seepage near Portage Lake at the Former Houghton County Gas & Coke (AOI 15)

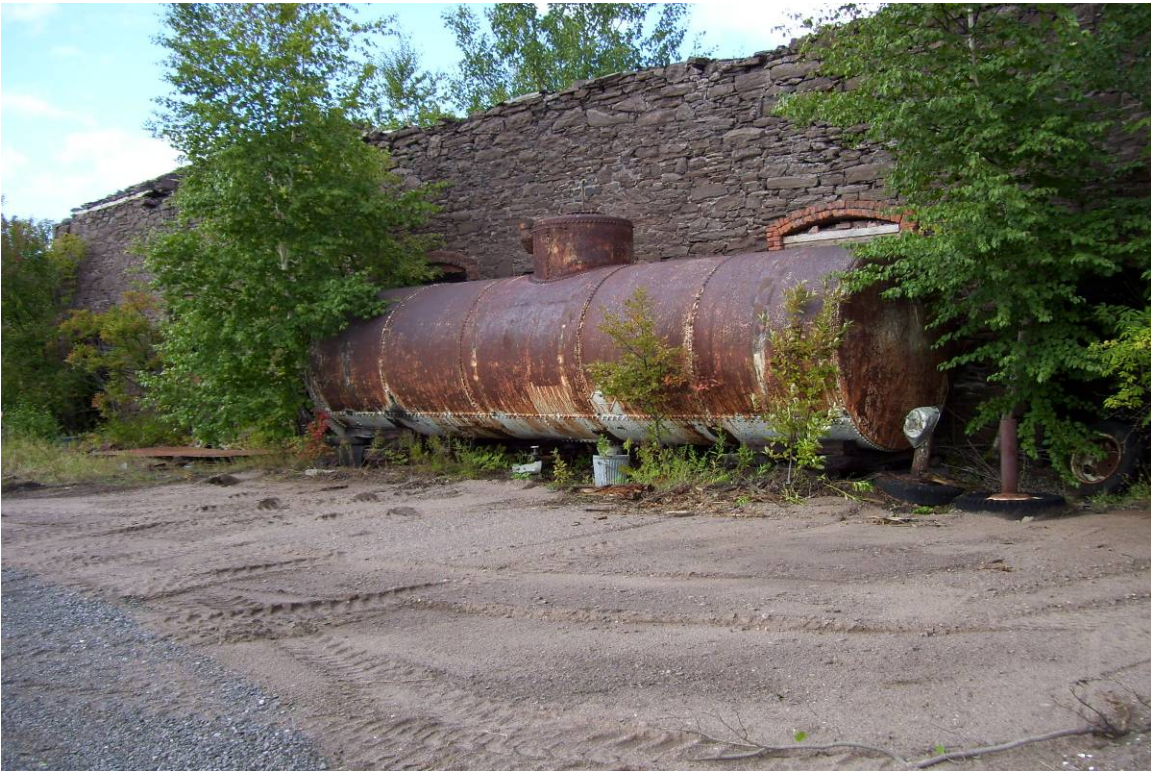
- A large AST that appeared to be leaking slowly from a spigot;
- Old Michigan Department of Transportation equipment used for road-building that may still contain tar-like materials; and
- An oil heater tank that may contain oil.

Subject: Large AST, possibly leaking, at Julio Property (AOI 15)

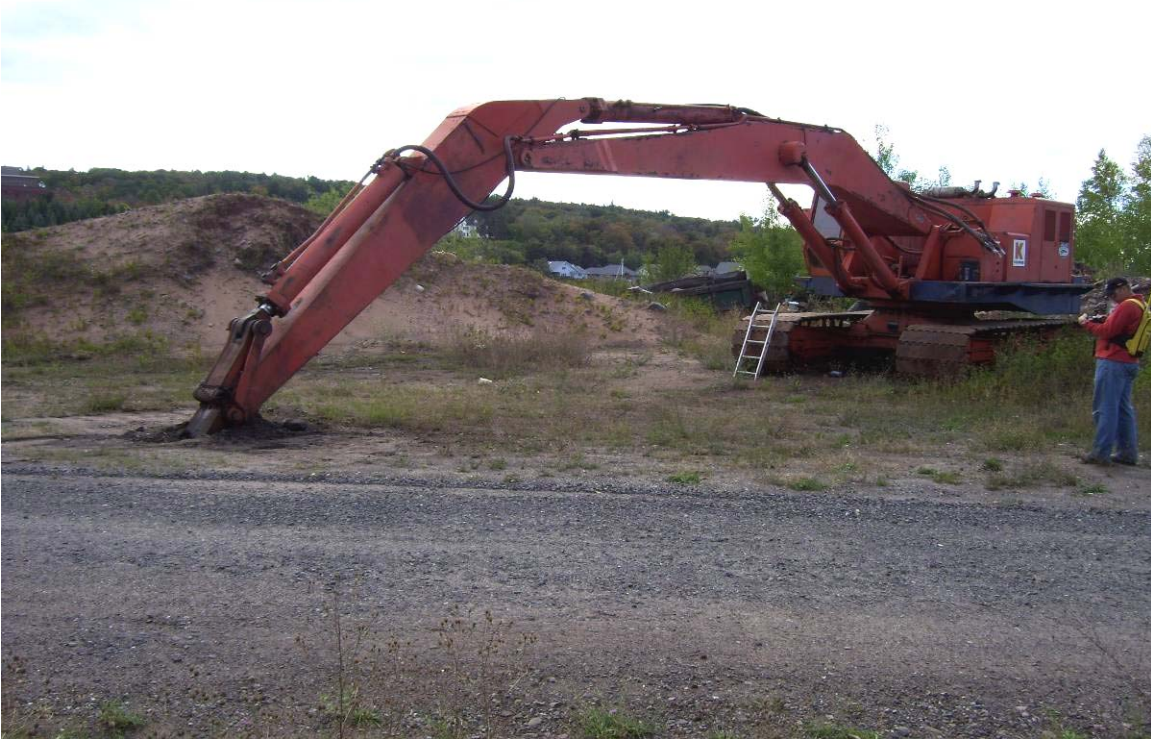
Subject: Large excavator leaking hydraulic fluid at Julio Property (AOI 15)

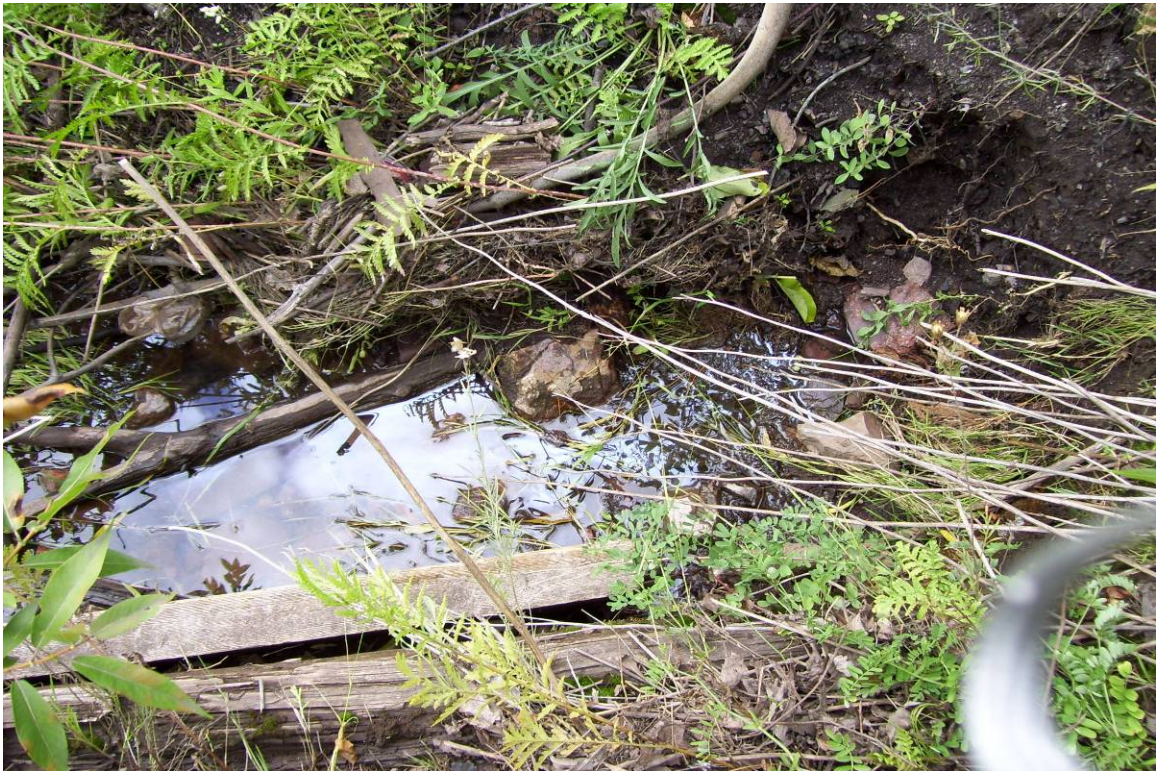
Subject: Sheen on surface of creek at Julio Contracting (AOI 15)

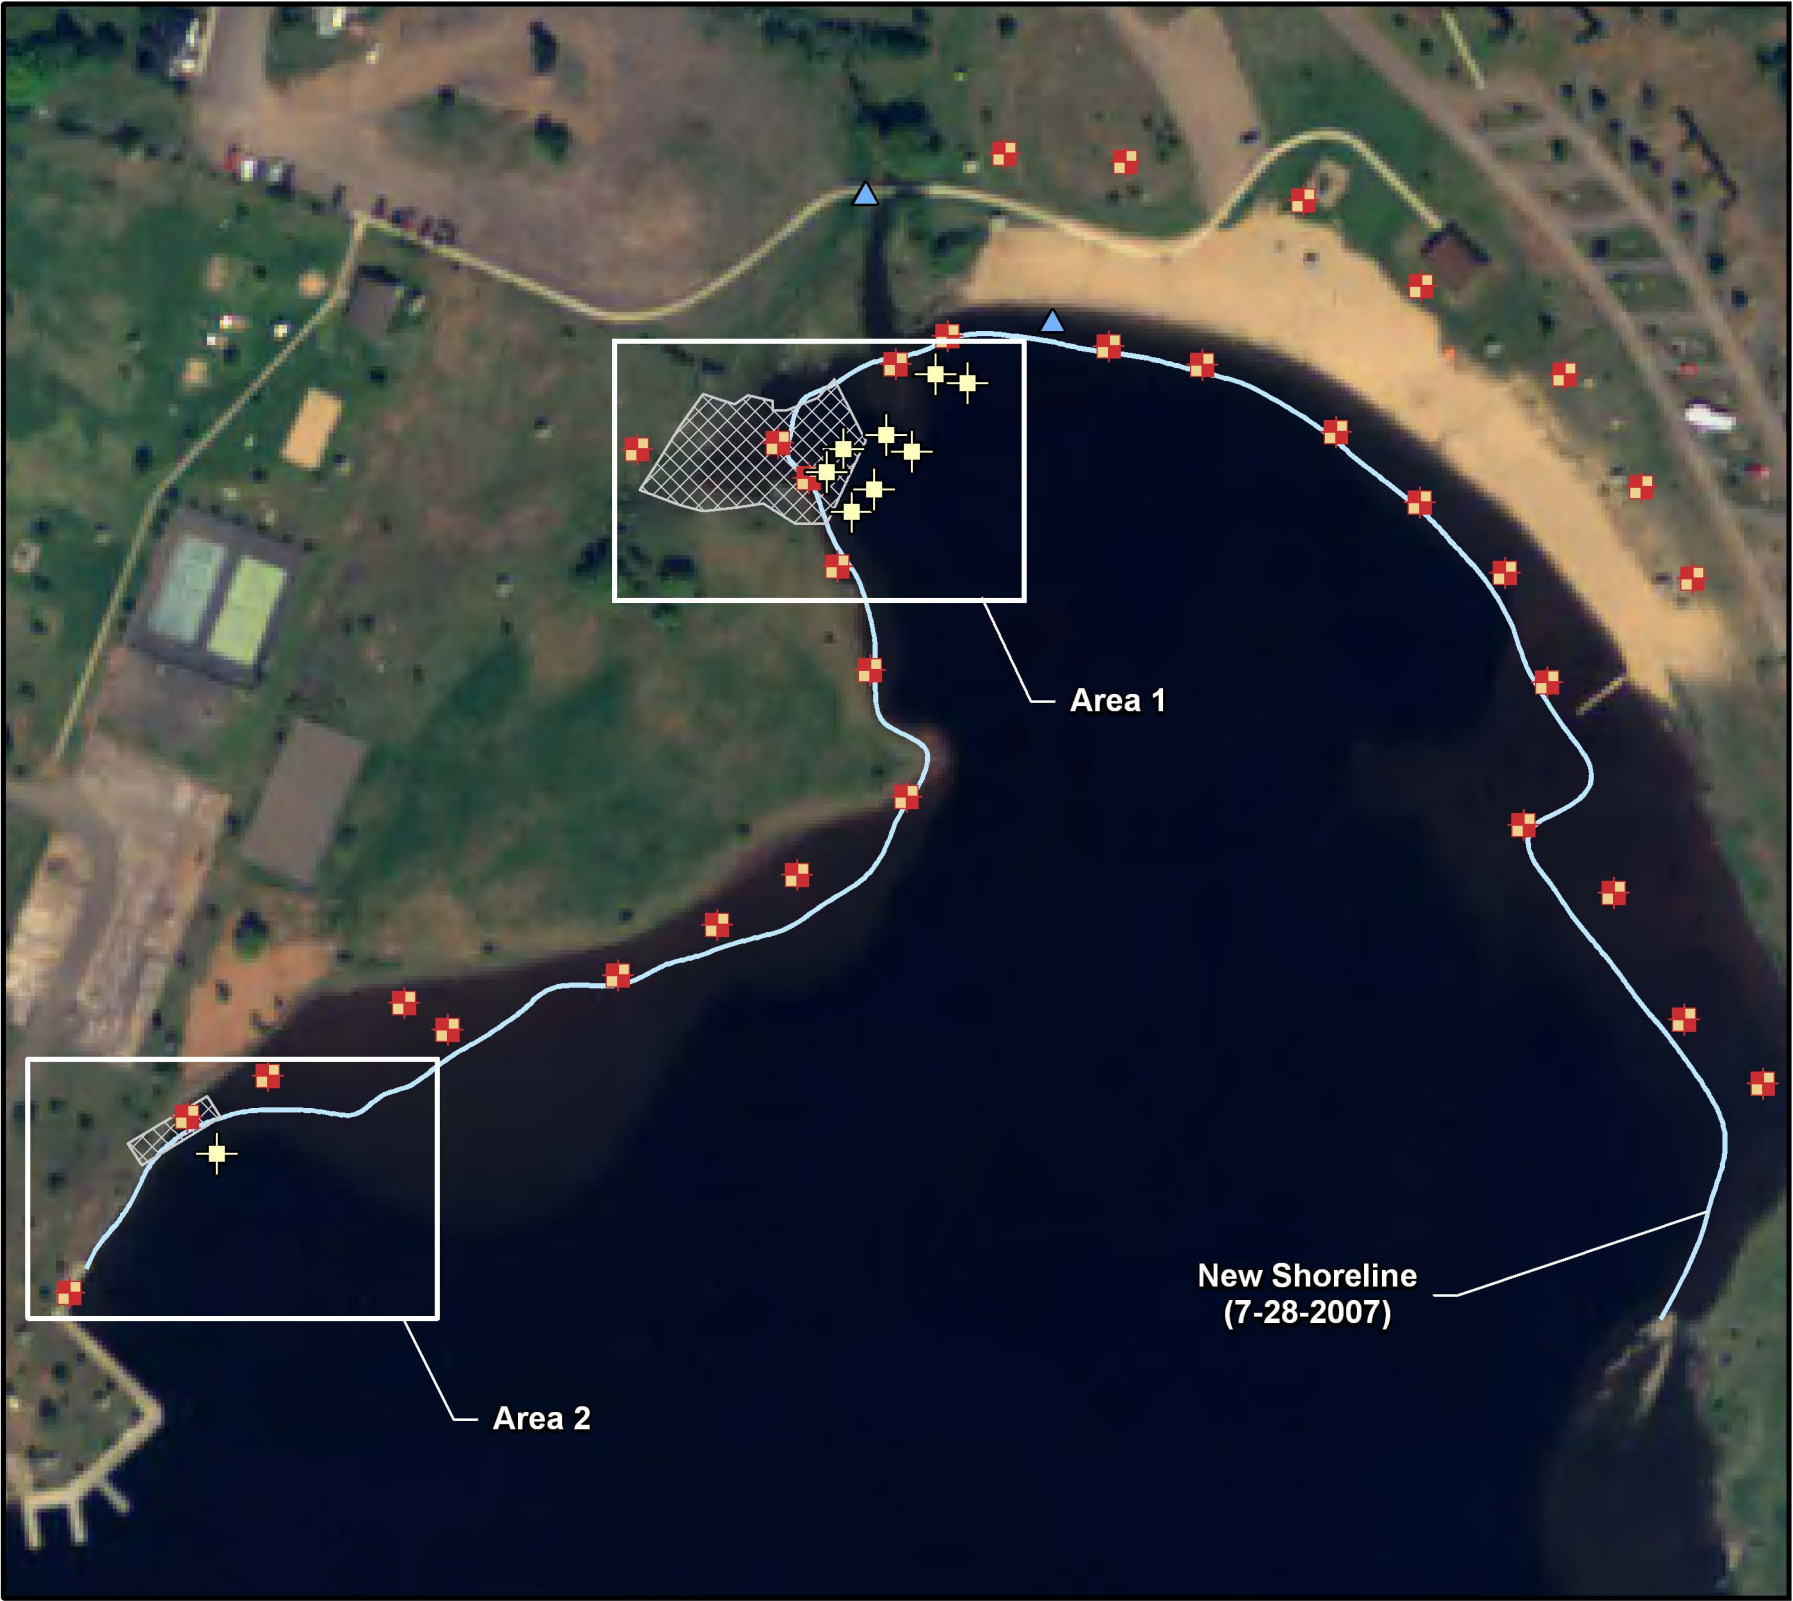
Attachment E-4

- Legend**
- Mud Puppy Sampling Locations
 - Soil Sampling Location
 - Water Sampling Location
 - Excavation
 - Shoreline (7-28-2007)
